AA-7633
Administrative Special Permit

Demolish the detached garage.

LIMITED ASBESTOS-CONTAINING MATERIALS SURVEY

LEAD-BASED PAINT INSPECTION FINAL TECHNICAL REPORT

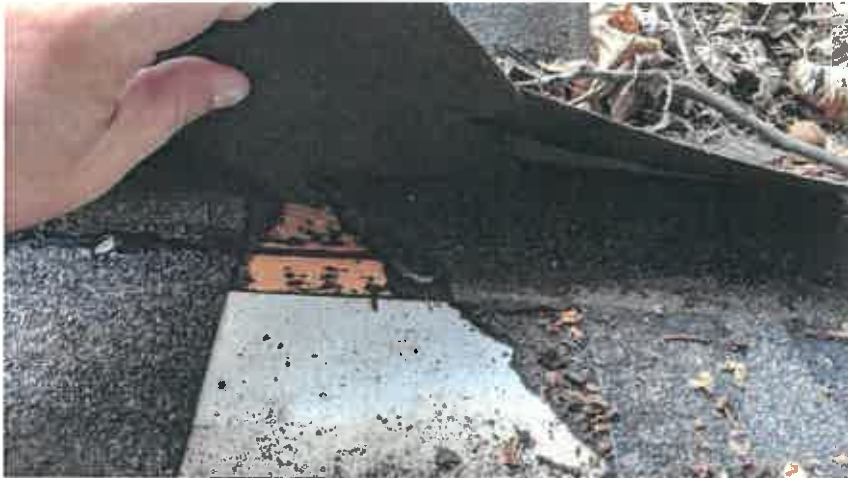
HA #1: Black Asphalt Roof Shingles & Associated Tar Paper

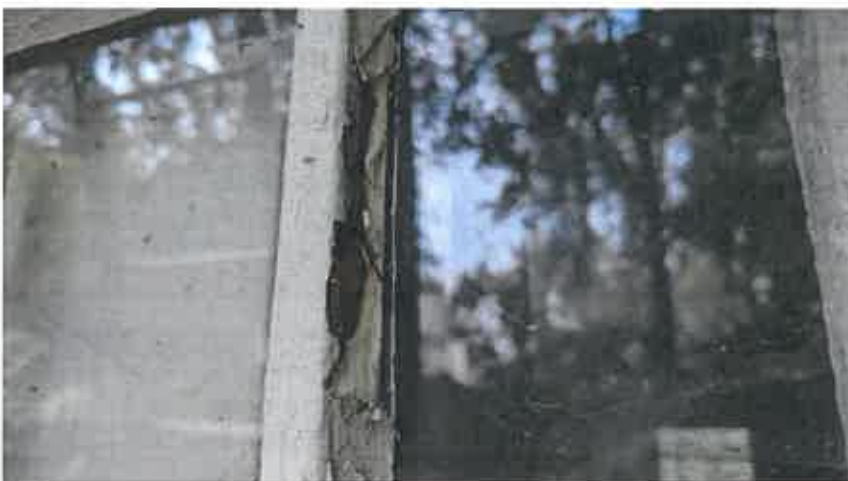
HA #2: Window Glazing Compound

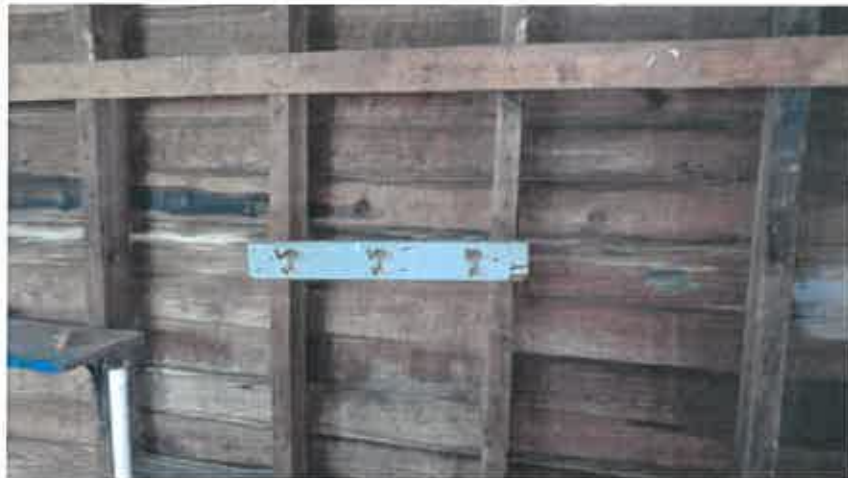
White Interior Garage Coat Hook

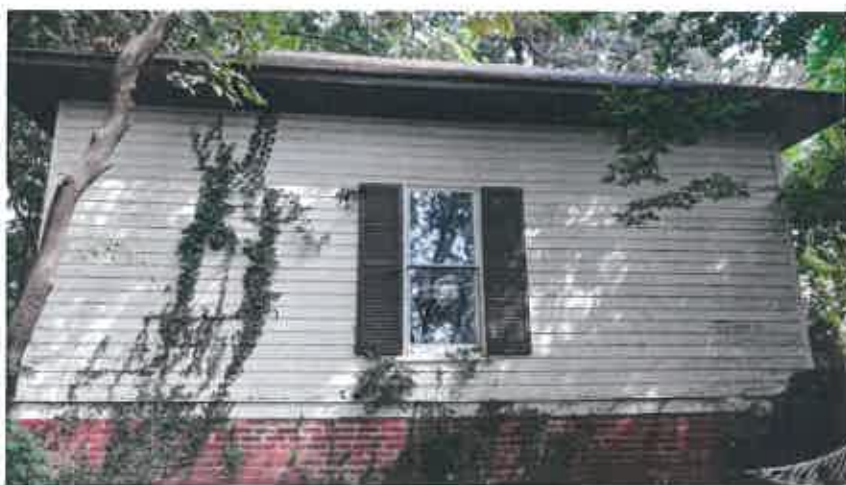
Exterior Wall, Shutter, Window, & Soffit
